MEMO TO FILE

The following information, Photos, has been separated from the rest of the original documents belonging to site, Bath Elec Systems (BES) ID # TXD065103327, because the material could not be stored at the Federal Records Center due to certain storage restrictions.

TDD# 06-8590-98 Pg. 1 of 20

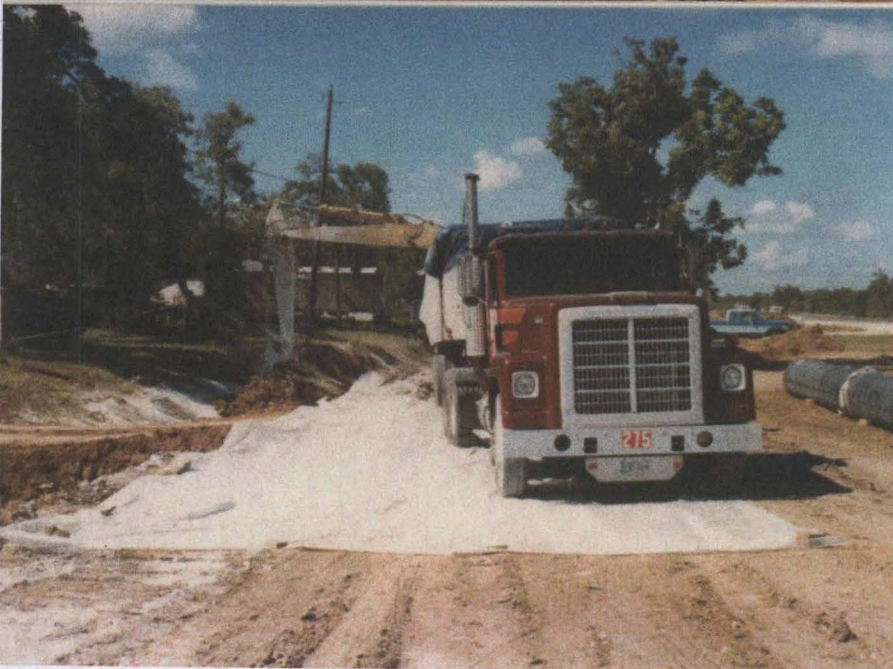
Photographer/Witness # 48

Comments: Excavation and loading
of PCB contaminated soil from ditch.
Truck is over 6 mil plastic.

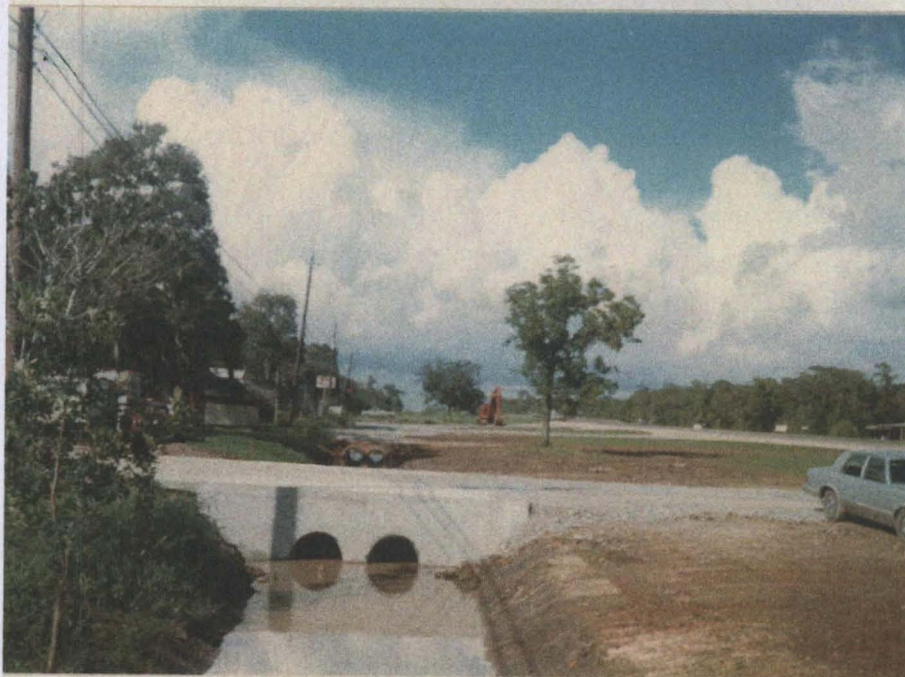
TAT-21-F- 01838

Comments: Restored drainage ditch and culverts looking north.

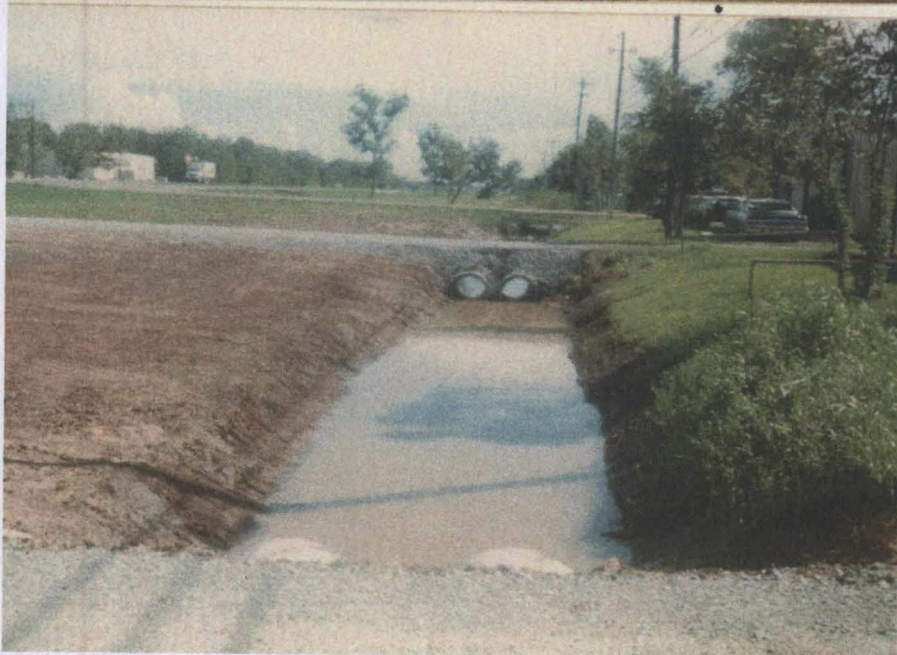
TAT-21-F- 01839

Comments: Restored drainage ditch and culverts looking south.

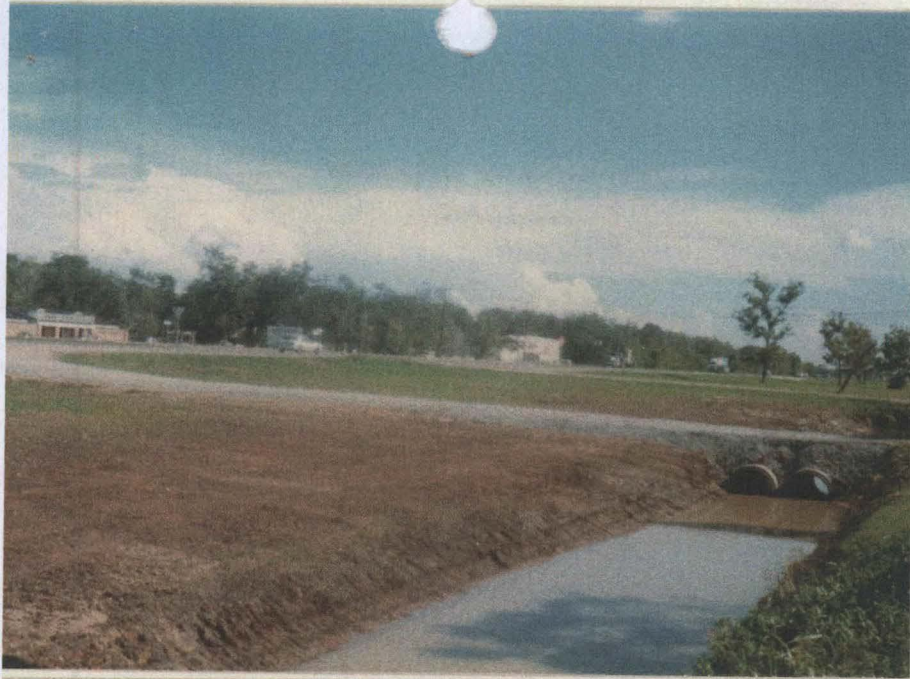
TAT-21-F- 01840

Comments: Areas to be hydromulched
looking south.

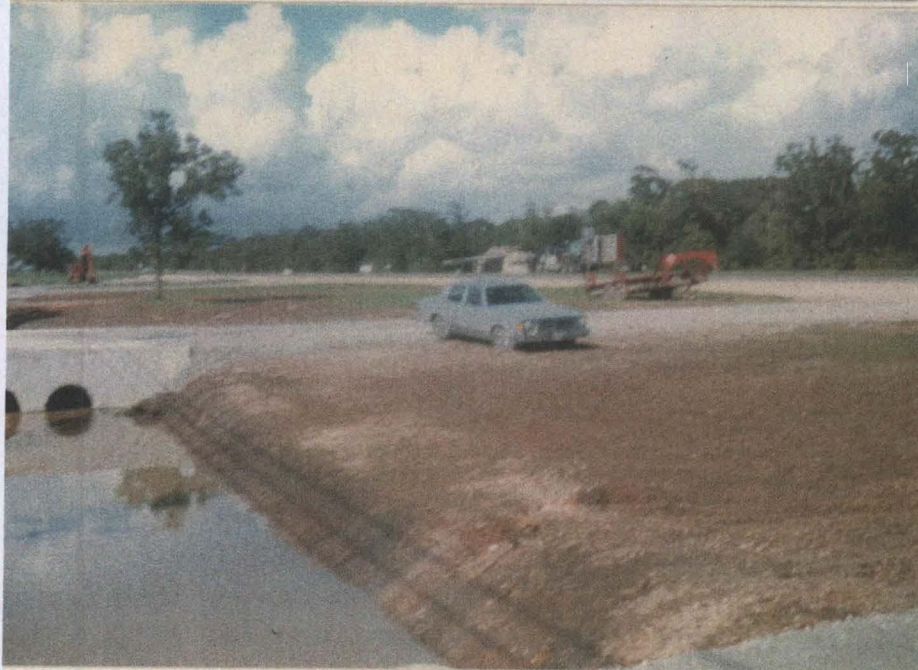
TAT-21-F- 01841

Comments: Areas to be hydromulched
looking north.

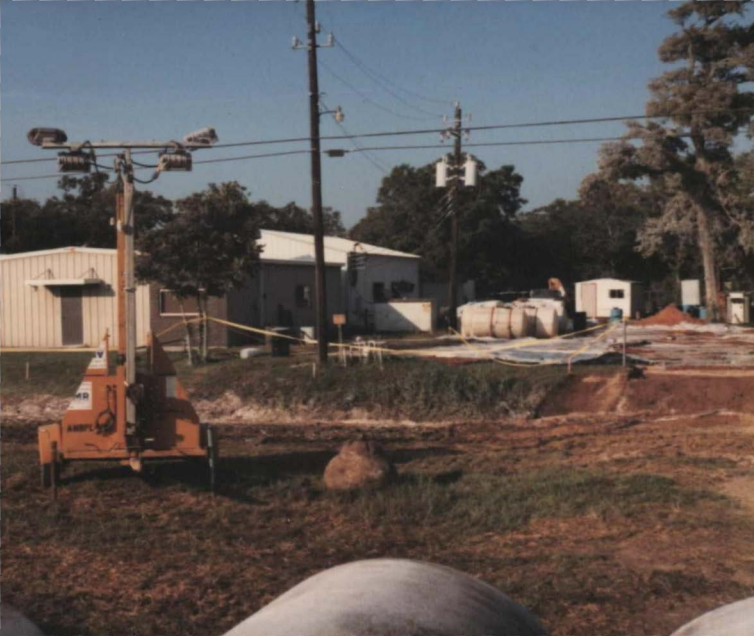
K-14

Another view of BES parking lot.
Tanks in the background
were involved in the Mill,
and were moved to this side
of parking lot.

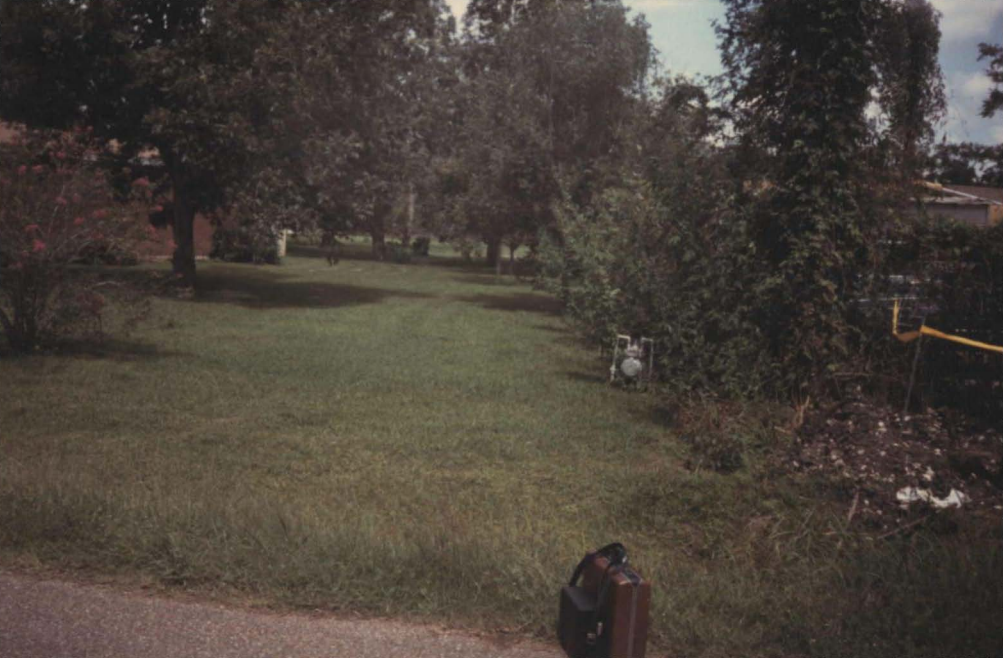
Small Puddle of Sewage
in Southwest corner
of property.

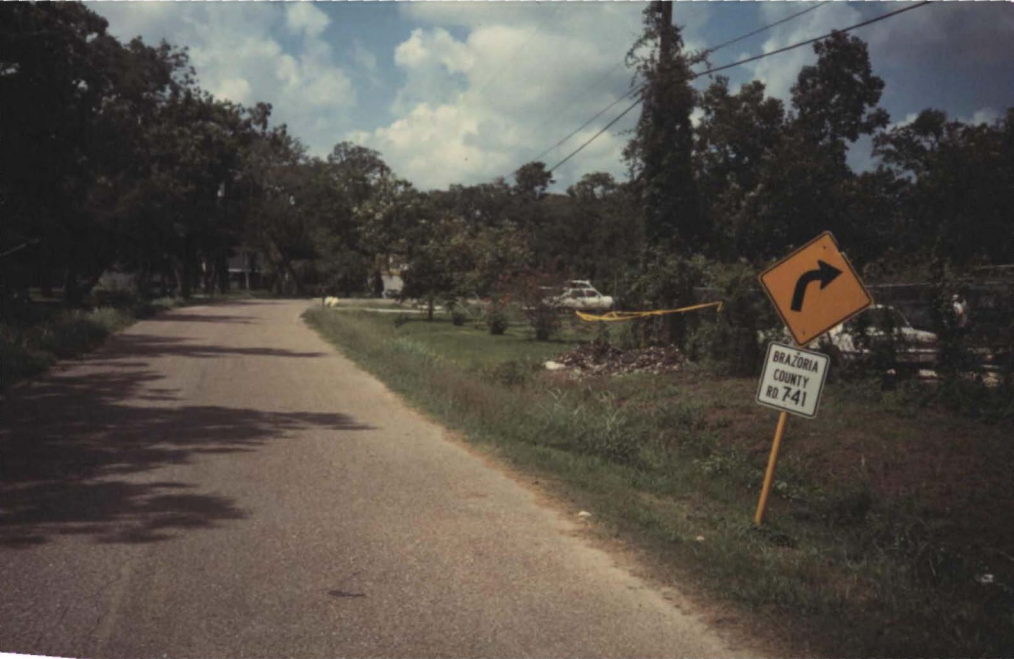
Residence behind west
boundary of BES.
